WATER MANAGEMENT DEFICIENCY, TRIGGER OF LANDSLIDES.

CASE STUDY BREAZA, ROMANIA.

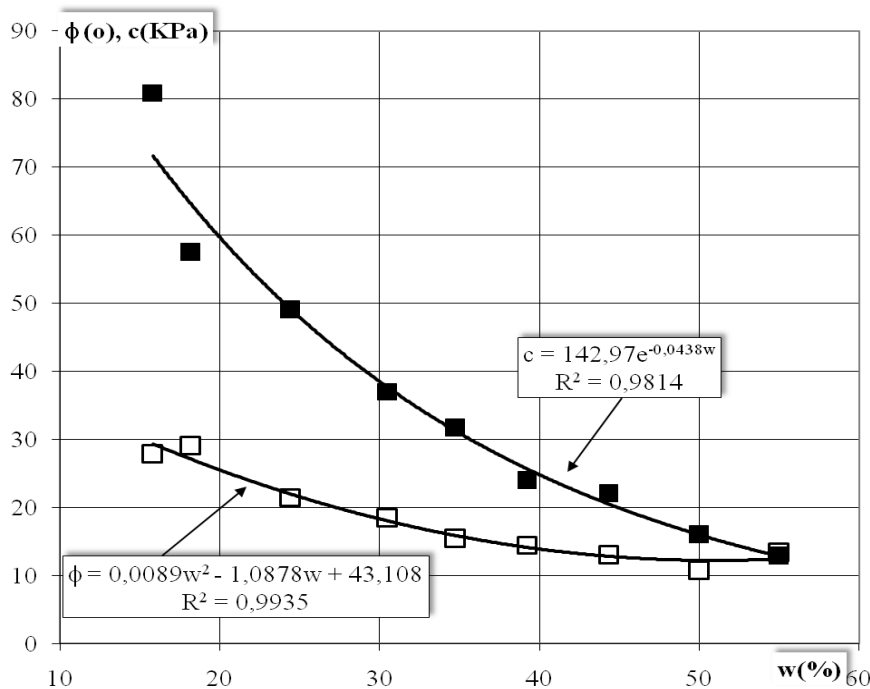
sandy fat clay (3%), with high plasticity and also established the limits of the fundamental indexes. Undisturbed samples of clays tested in direct shear mode (unconsolidated-undrained) put in evidence values for direct shear parameters, in ranges of 16°-20° for friction angle, respectively 23-35KPa for cohesion, which was found in agreement with results of triaxial compression ($\phi=21^\circ$, $c=42\text{KPa}$; $\phi'=25^\circ$, $c'=57\text{KPa}$). Remoulded samples of fat clays from sliding mass has been tested at moistures between 18-55%, in direct shear apparatus. Results are presented as the variation of shear parameters with moisture, in fig.1 bellow. The fitting curves obtained for $c=f(w)$ and $\phi=f(w)$ dependencies are exponential and polynomial with notable correlation coefficients 0,98-0,99. Saturated hydraulic conductivity of sliding soils was tested by three types of tests: by falling head permeameter ($2\div 3\cdot 10^{-4}\text{ cm/s}$), by the constant head in the triaxial cell ($4\cdot 10^{-7}\div 5\cdot 10^{-6}\text{ cm/s}$) and indirectly obtained from consolidation tests in odometer ($2\cdot 10^{-5}\div 8\cdot 10^{-4}\text{ cm/s}$). Stable soils represented by fat clays has been also tested and average values was found in contrast with the previous results of sliding mass soils: $\gamma = 20,4\text{KN/m}^3$; $\gamma_d=15,9\text{KN/m}^3$; $n=40\%$; $S_r=0,55$; $\phi=28^\circ$, $c=80\text{KPa}$ (direct shear, UU); $k=3\cdot 10^{-6}\text{ cm/s}$ (falling head method).

Fig.1. Variation of direct shear parameters with moisture

2. Regarding the tight intercourse between moisture content and shear parameters, we established for this particular case, (on remoulded samples of fat clays from sliding mass), laws of variation $c=f(w)$ and $\phi=f(w)$ with notable correlation coefficients.

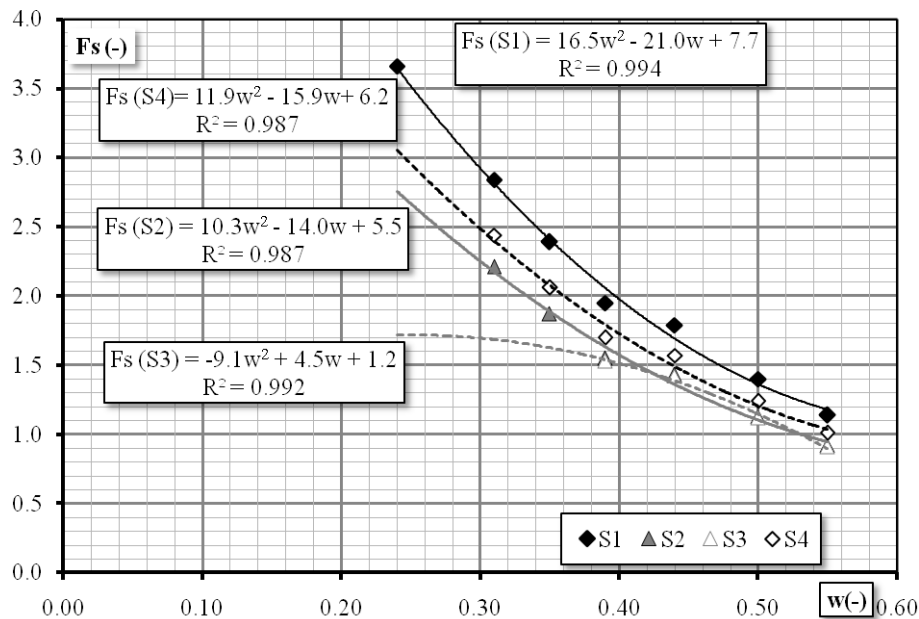
moisture content. These equations allows defining the critical moisture of each surface as the moisture which induces through associated shear parameters, the limit equilibrium of the sliding mass ($F_s=1$). For all the four sliding surfaces, the trend equations are presented in figure 2.

Fig.2. Variation of the stability factor with increasing moisture

Slope stability analyses were executed using an automatic programme based on Janbu theory (Janbu, 1954) for four sliding surfaces. The geometry of sliding surfaces specified by geophysical surveys together with main properties of interslice forces. Each surface was analysed in various conditions of shear resistance dictated by moisture content, in the limits of parameters described in previous section. Results consist in ranges of decreasing factors of safety with increasing moisture, corresponding to each sliding surface and are presented in table 1. Also, for every specified sliding surface, a representative trend equation has been established for the factor of safety versus

- moistures over 45%, induces alarming values of safety factors under 1,3;
 - moistures over 50%, induces small, local sliding on superficial slip planes;

- moisture content over 53-57%, may produce a large or even an overall sliding on the deepest shear plane (about 15m depth) because the range of critical moistures ($F_s=1$) of tested sliding surfaces extends between these limits.
